Northern Views

Issue No. 334

April 2020

Clubrooms and Running Track at Whangarei Heritage Park SH14 Maunu

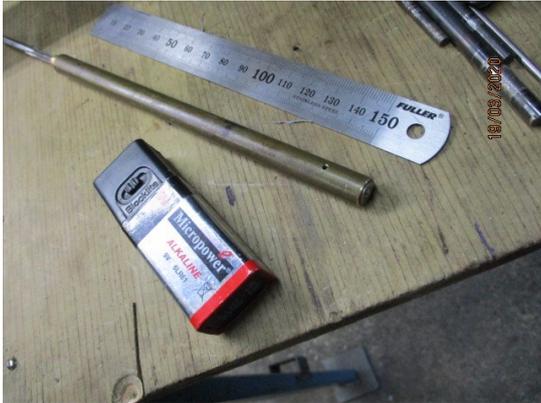
Coupled wheel lubrication tube

I cut 3 lengths of brass pipe that was 3/8" OD and 11/32" ID to be the distance from the INSIDE of the LH frames to the OUTSIDE of the RH frames (about 6"). To the LH end of each, I force fitted a turned brass spigot that extend the length by the thickness of the LH frames (6mm). These spigots were blind drilled and tapped 5mm. The tap being a quite loose fit (see reason for this later). The other end was also fitted with a drilled through spigot that was also forced into the brass pipe. The spigot hole was sized to force fit the ball oiler. I then drilled No 50 drill holes to be directly above each of the 6 cups associated with the axle boxes. Another No 50 drill hole was made centrally at 12 o'clock to allow air into the pipe (and thus allow oil to drip out. On one of the pipes I drilled a further hole exactly over the oil cup of the centre crank big end. I set one of the pipes up and squirted oil in via the ball end fitting and watched what happened. The occasional drip occurred at each bottom drilled hole.

I now drilled the main frames through a convenient spoke gap in the main wheels. Drilling as low as I could to get the oil drips to fall into the oil cups when the engine was stationary. This was easy for the trailing wheels (no interfering gear between frames). For the leading wheels I had to drill the holes to clear the cross slide runners which put it a little above the trailing wheel holes. For the driven wheels, I drilled as high as I could get to the wheel rims. All three oiling pipes were then fitted and loctited into the frames.

Getting them into position was difficult and hence the easy fit 5mm tap in the small end spigot. This eased the problem of being on one side of the engine and push the tubes through and having to be on the other side to get the spigot into its tight hole resting place. The loose tap allowed this and a tap with a handy hammer got them all in place with Loctite not overly spread around.

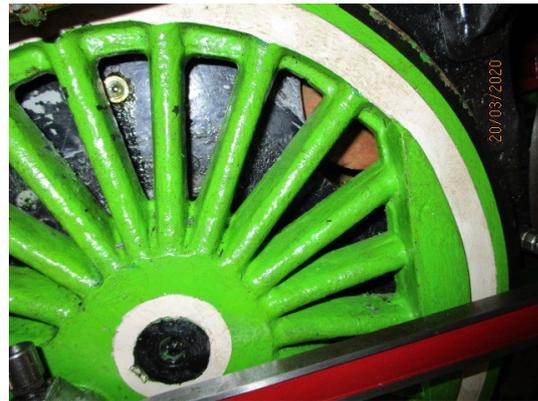
Coupled wheel lubrication point

Anyway, a new oil cup was made up and the crank reassembled and the oil system tested. At rest with the centre crank set so that the oil cup is below the drip feed, the oil cup filled in a around 10 minutes. Found out that only a couple of good squirts from the oil can were needed. Otherwise too much oil. The drips into the centre crank cup would mainly miss the cup when travelling of course, but the oil drips would occasionally get into the cup or onto the bronze split side bushes.

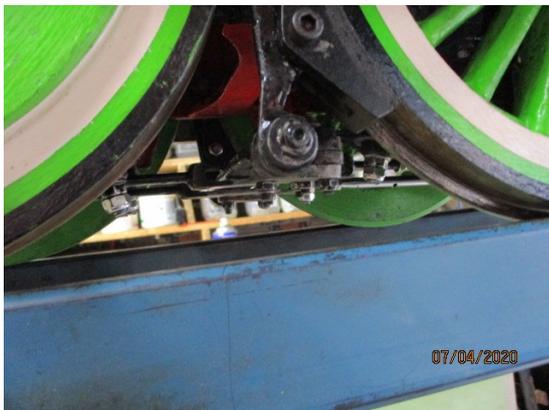
Brake mechanism raised 16mm

While I had the engine hanging for the above job, I raised the whole brake mechanism system by 16 mm to more align with Don Young's intentions. I had upsized the 5" drawings to 7 1/4" some years ago and got the conversion scaling wrong. Not the first scaling error I might add.
